Wetland Mitigation Area A2 and Portions of the Rockland Road Connector

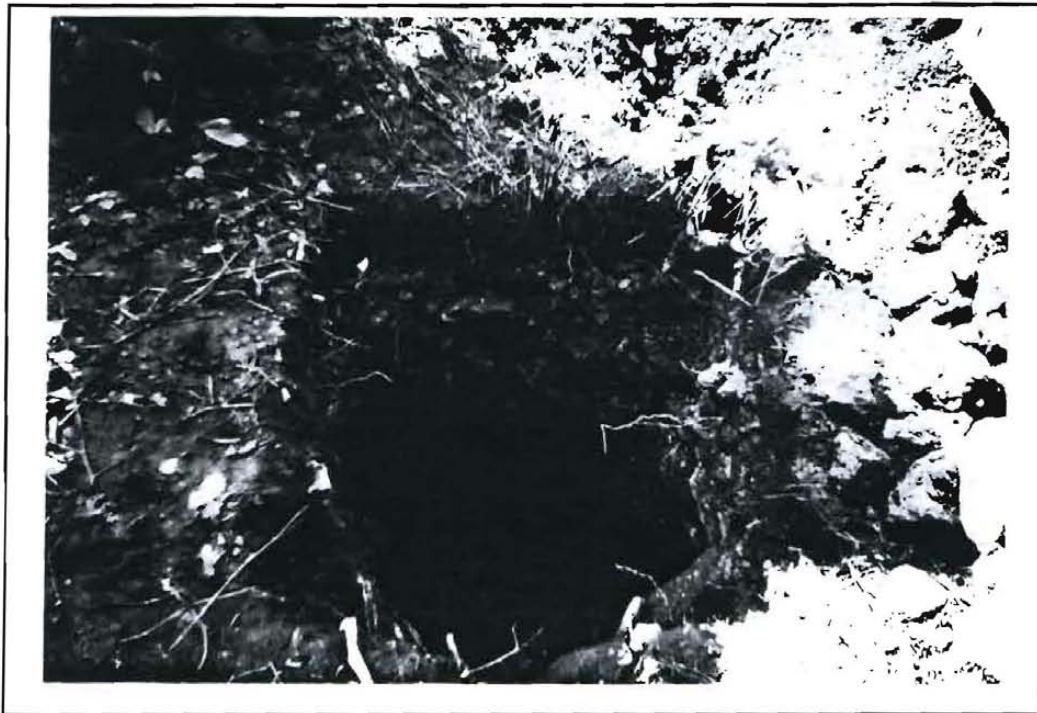
FIGURE 11
Wetland Mitigation Area 2A
Test Unit 17, North Wall, Showing Buried Rubble
Overlying Ab Horizon

Excavation of TU 16, about 20 feet from Alapocas Run, revealed a one-foot thick layer of loose stone, brick and mortar rubble underlying 0.5 feet of Ao/A horizon (Figure 11). This rubble was about one foot thick, extending a maximum of 1.6 feet below the surface and mixed with dark gray brown [2.5Y 4/2] sandy loam. A pre-1860 freeblown olive amber bottle glass fragment, a post-1850s peacock bottle sherd, a pale aqua bottle sherd, an unidentified piece of glass, two soda/lime windowpane fragments, three post-1790 cut nail fragments, clam shell fragments, and several grams of brick and mortar fragments were recovered from this rubble. The mortar did not adhere to the brick or stone, but occurred in pockets. No articulated building remains were found. A buried weak red [2.5Y 5/4] clay silt Ap horizon approximately 0.3 feet thick was found beneath the rubble; this yielded a pearlware sherd and brick and mortar fragments. The thinness of this buried plow zone suggests that it had been truncated. The buried Ap overlay a series of alluvial soils, none of which produced artifacts. The first of these was a very dark gray [5YR 3/1] clay silt, the second a brownish yellow [10YR 6/6] coarse sand, and the lowest a very dark gray [5YR 3/1] clay directly above the water table (Figure 12).

Four shovel tests were excavated to the northwest, northeast, west and east of the rubble at varying intervals to determine its extent. These units revealed that the rubble extended a minimum of ten feet to the north and five feet to the southwest, evidently in a linear fashion. It appears that the rubble had been dumped on an earlier surface, possibly to contain the creek during flooding or to fill in a low spot. An earthen berm and a ditch are located on the opposite bank approximately thirty feet from the creek, and both that berm and the rubble feature may serve the function of controlling floodwater erosion, although the berm east of the creek is more formally constructed. The pearlware sherd from the Ab is probably field scatter, but does suggest that the rubble was dumped after 1820. Previous testing in this area also produced a thin historic field scatter (Taylor et al. 1989:270).

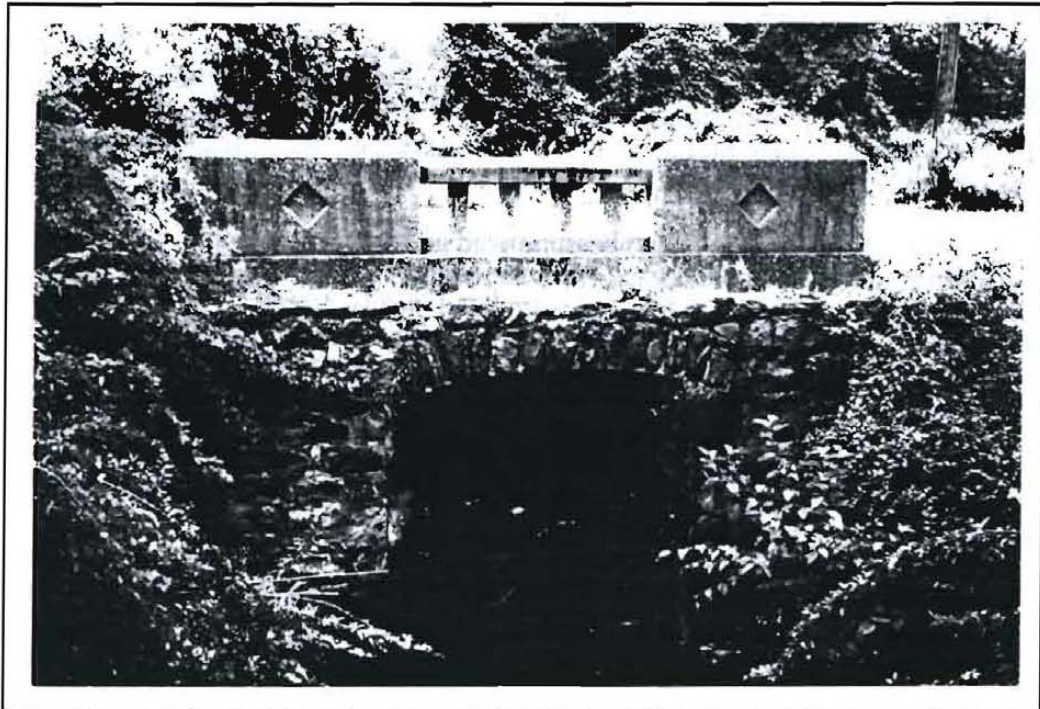
FIGURE 13
Wetland Mitigation Area 2A
Looking South at Arched Stone Culvert;
Alapocus Run Flows Under Rockland Road

A mortared arched stone culvert (Figure 13) allows Alapocas Run to flow under Rockland Road. This culvert appears to pre-date the cast cement that forms the above ground "side rail" portion of the bridge. Stone walls run intermittently along either side of Rockland Road from its intersection with Concord Pike to the west side of the project area. A 1930s aerial photo (Aero Service 88.8.214) shows these walls. The stone culvert also appears to be indicated on the 1917 Price and Price map of the Nemours estate. It is our recommendation that the stone arches be photographed, drawn and studied by an engineer if they are to be impacted. No further archeological work is necessary in this area.
